# Hall of Waters

The Hall of Waters is significant geologically, commercially, and medically as the site of this first spring discovered in town, Siloam Spring. Siloam Spring, at that time, was the only natural supply of ferro-manganese mineral water in the United States and one of only five known worldwide. At the very onset of the PWA program in 1933, the City petitioned for a loan and grant to complete an ambitious mineral waters project which would consolidate all the springs and wells, and build a comprehensive city-owned hydrotherapy and mineral waters system. When Missouri's PWA projects were finally approved in 1935, the Hall of Waters project was second on the list.

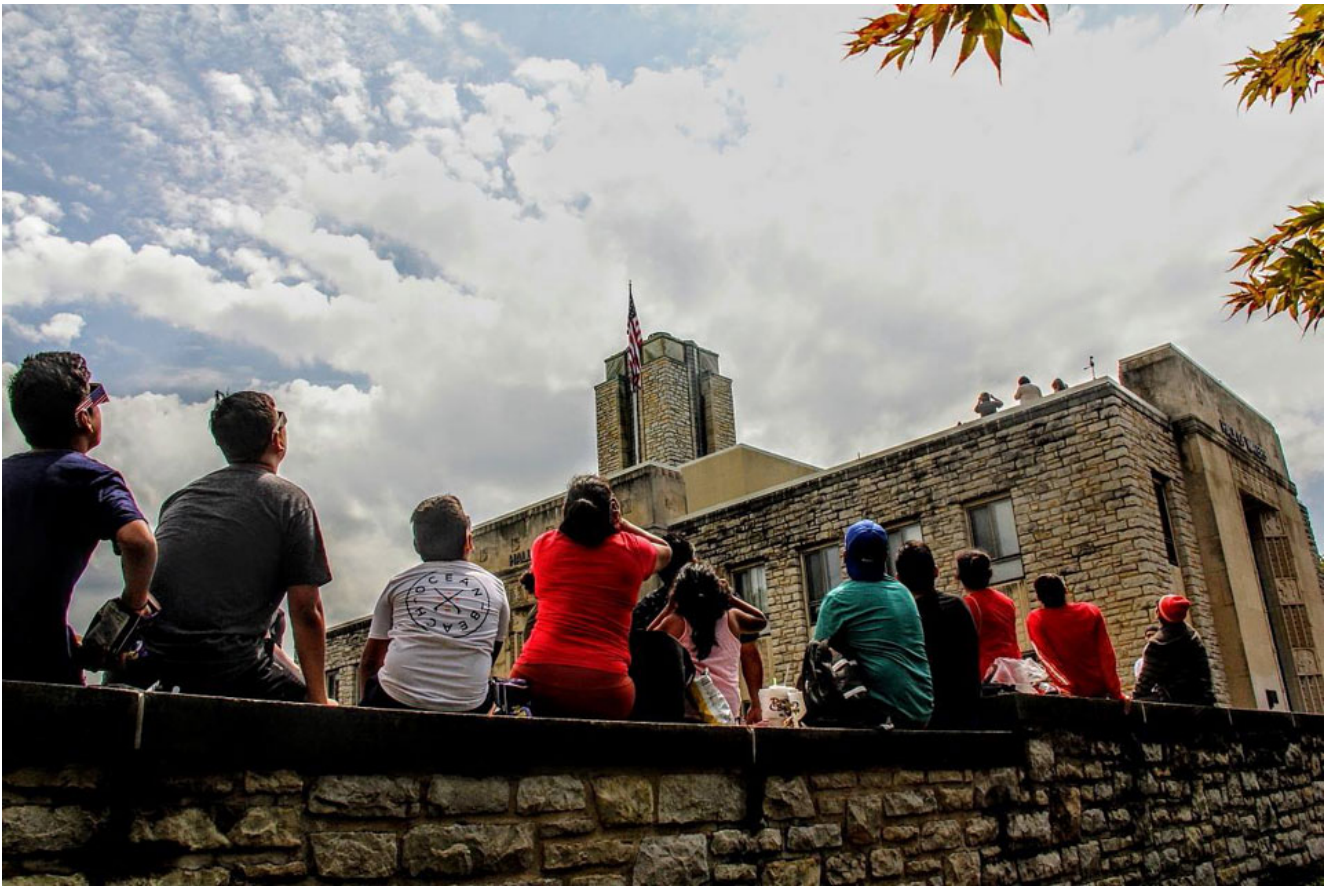
Built from 1936 to 1939, the Hall of Waters is generally a “T” shaped building. The majority of the structure is cast in place concrete with an exterior skin of ashlar stone, cast stone with carved limestone accents, and exposed concrete. There are a total of five levels with four above ground and a basement story completely underground. Exterior trim includes glazed tile, cut stone, and various metals, including the elaborate bronze main entry doors.

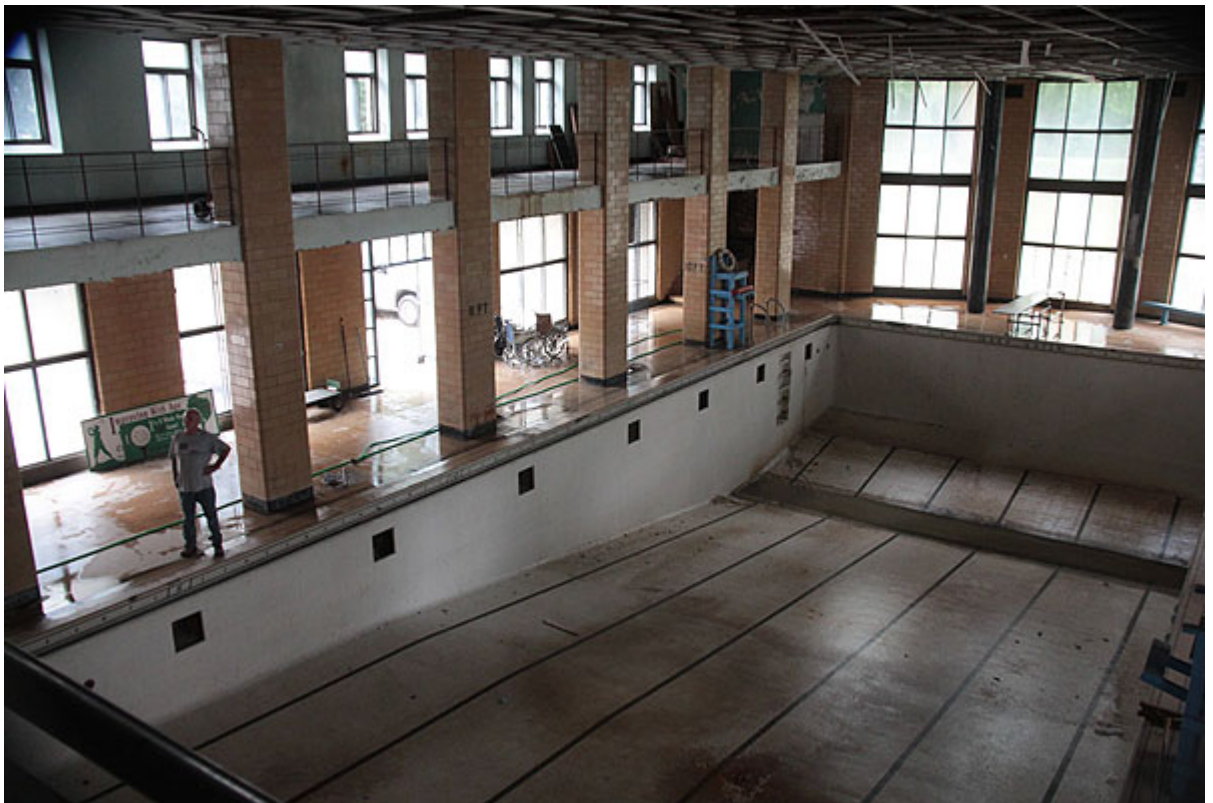
Competition-size swimming pool and viewing balcony located under the Hall of Springs.

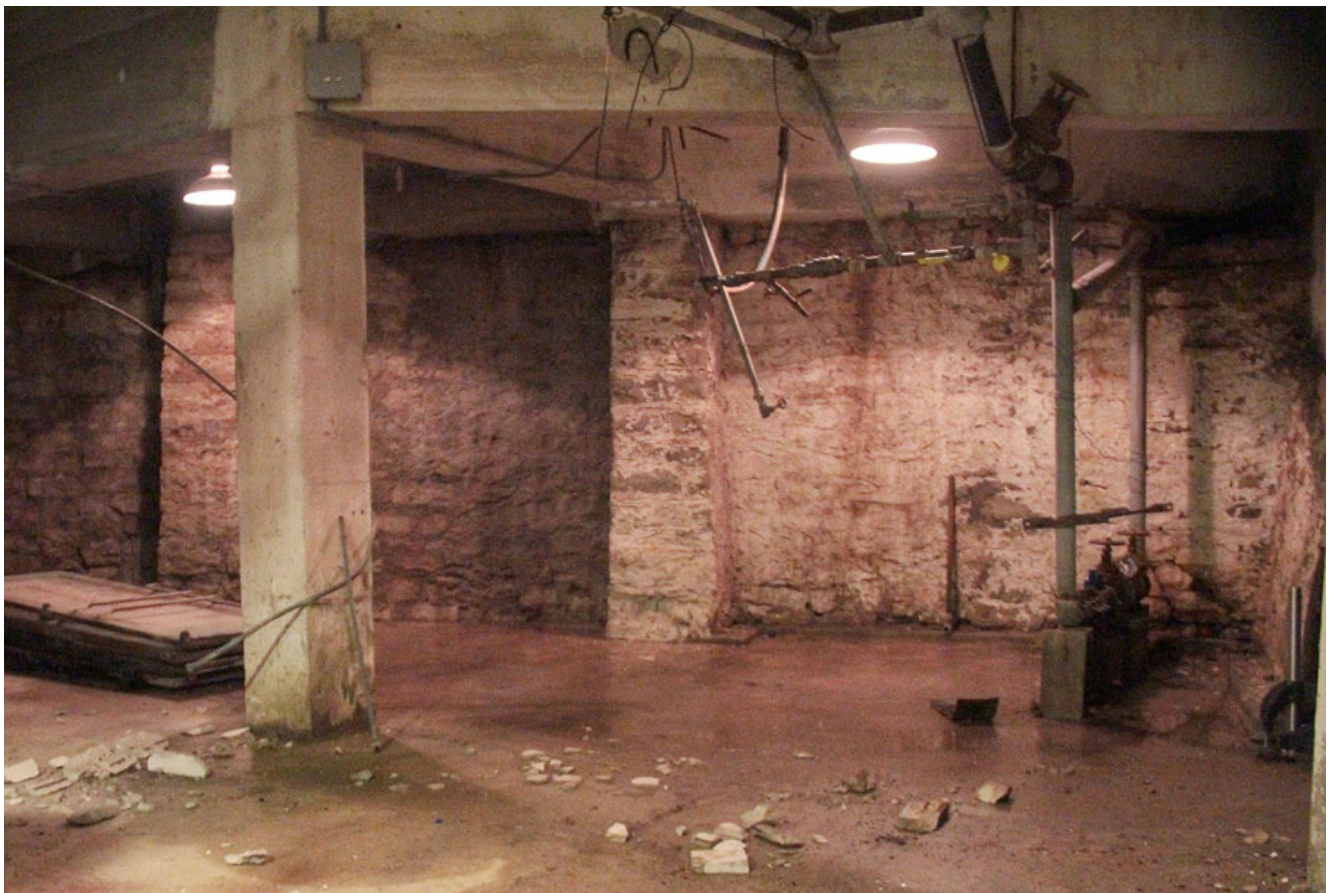
Deterioration in the well room, which houses Old Siloam, our original spring. The well room features the last remaining portion of foundation to the Siloam Pavilion, which was designed by landscape architect George Kessler, as well as other remnants from our past. These areas need to be conditioned through a proper ventilation system to stop the deterioration of lower building levels.
